TECHNICAL DATA and TEST RESULTS

TEST RESULTS WATER PENETRATION

TEST RESULTS WATER PENETRATION AT WINDOWS

WIND LOADING ON METAL STUD WALL SYSTEM

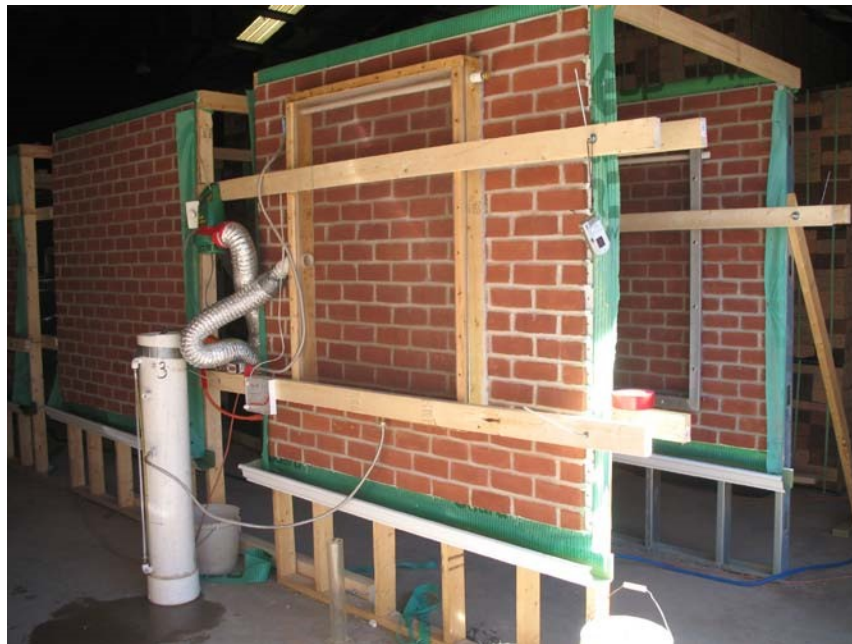
Figure 1;
E514 Test Chamber on Wood Stud Sample Wall (foreground) and Metal Stud Wall (behind)

Type 2; Tru-Brix siding installed over 5/8" Fiberglass faced exterior gypsum sheathing (Georgia Pacific Dens-Glass Gold) on 18 gage steel studs spaced at 16-inches on center. Three wall samples of 6-ft x 6-ft were built and two were tested. The E514 Test chamber was 40"W x 48"H and attached in the approximate center horizontally, and 2 courses from the top, on each test wall. (See Figure 1)

The test walls were constructed with a trough below the test area to collect water. (See Figure 1) The procedure called for measuring the water that was collected in the trough, measuring any water that might penetrate into the drainage wrap and drain to the bottom of the test panel, and observing any wetness behind the sheathing with emphasis on monitoring the screw penetrations.

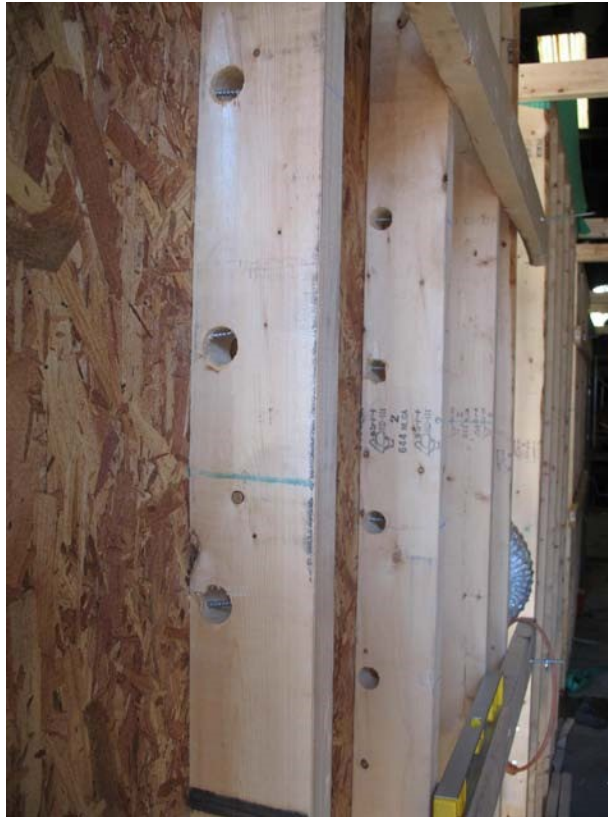
**Figure 2;
 Observation holes at anchoring screws in wood studs**

Test Samples: Type 1; Tru-Brix Siding installed over 7/16" OSB Sheathing on untreated 2x4 wood studs spaced at 16-inches on center. Three wall samples of 6-ft x 6-ft were built and two were tested. The E514 Test chamber was 40"W x 48"H and attached in the approximate center horizontally, and 2 courses from the top, on each test wall. (See Figure 1) Holes were drilled in the wood studs close to the sheathing in order to expose eight Siding attachment screws for observation. (See Figure 2)

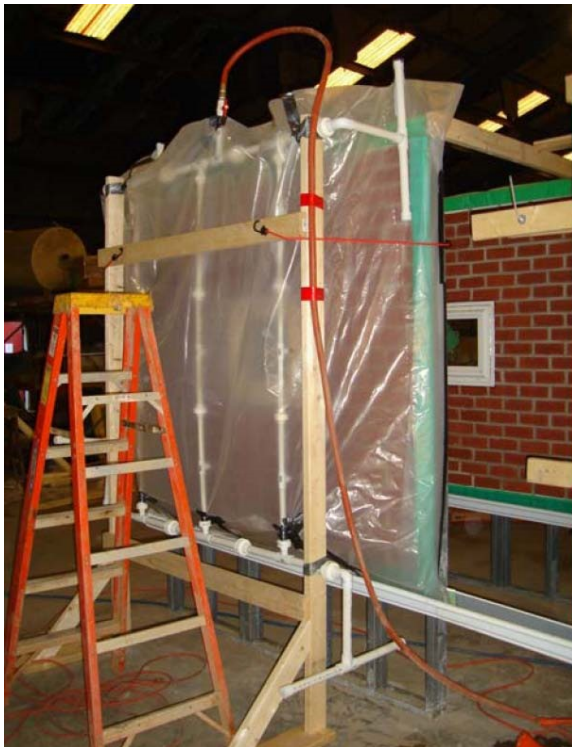
Figure 3; E1105 Setup

Test samples: Type 1; Tru-Brix Siding installed over 5/8" Fiberglass faced exterior gypsum sheathing (Georgia Pacific Dens-Glass Gold) on 18 gage steel studs spaced at 16 inches on center. A flanged 16" x 16" fixed window was installed with standard construction methods. The E1109 spray test apparatus was set up and plastic covering was installed around the test apparatus. See Figure 3.

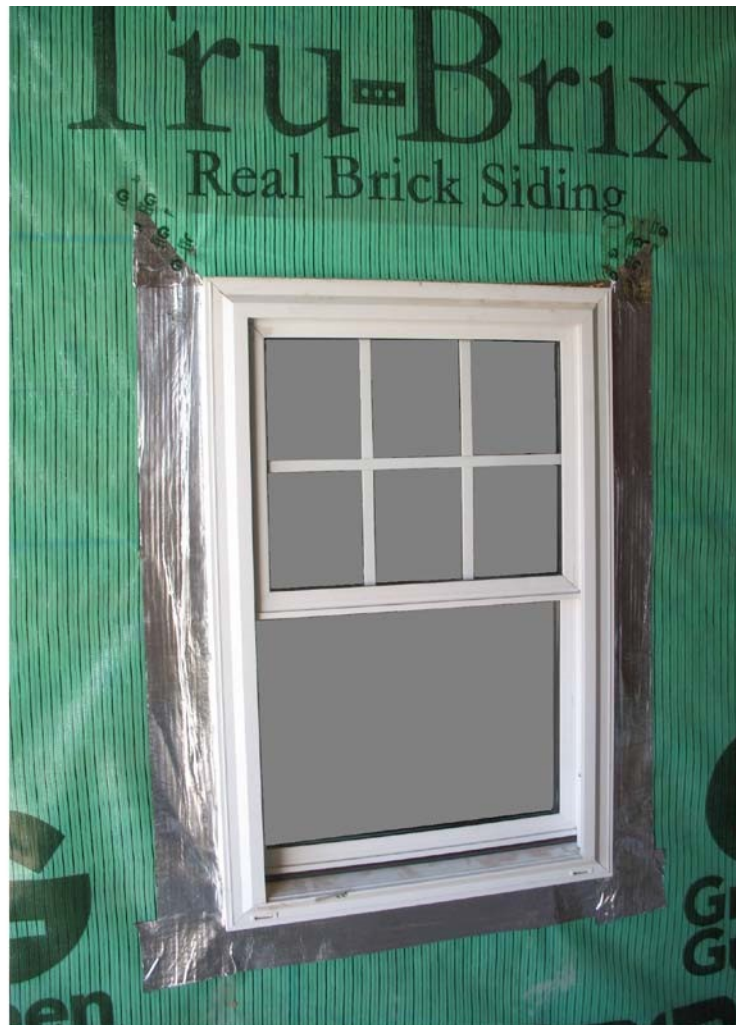
Figure 5; Window with Drainage Wrap and Flashing

Results; Examinations of the results show that correct window flashing details are required to prevent water penetration at window heads. The correct installation is shown in Figure 5. The Drainage Wrap must be cut to install window head flashing underneath the Wrap. Any moisture in the Drainage Wrap will then be removed from the wall by the window head flashing.
