Redland

Tru-Brix Real Brick Siding

TECHNICAL DATA and TESTING RESULTS

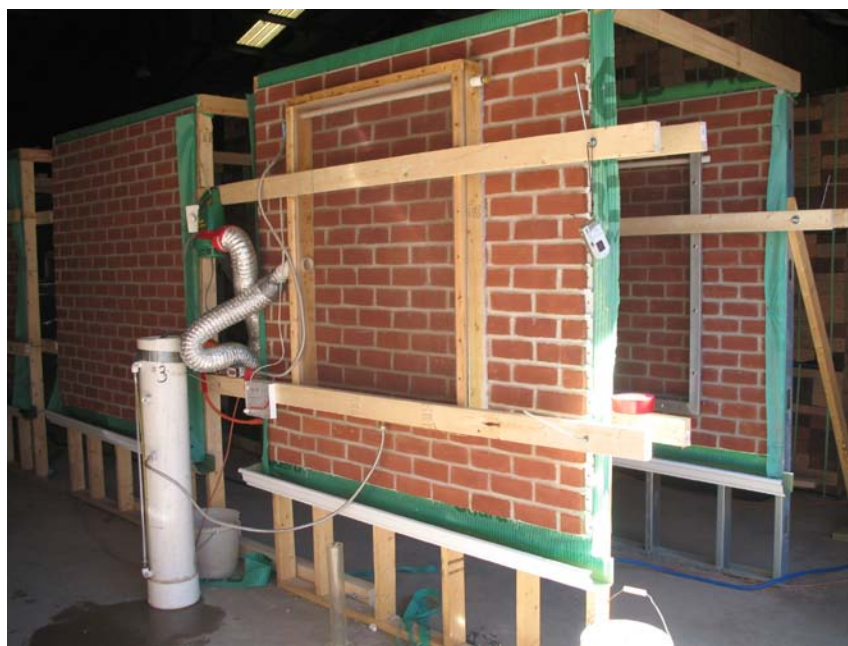
Figure 1;
E514 Test Chamber on Wood Stud Sample Wall (foreground) and Metal Stud Wall (behind)

Type 2; Tru-Brix siding installed over 5/8" Fiberglass faced exterior gypsum sheathing (Georgia Pacific Dens-Glass Gold) on 18 gage steel studs spaced at 16-inches on center. Three wall samples of 6-ft x 6-ft were built and two were tested. The E514 Test chamber was 40"W x 48"H and attached in the approximate center horizontally, and 2 courses from the top, on each test wall. (See Figure 1)

The test walls were constructed with a trough below the test area to collect water. (See Figure 1) The procedure called for measuring the water that was collected in the trough, measuring any water that might penetrate into the drainage wrap and drain to the bottom of the test panel, and observing any wetness behind the sheathing with emphasis on monitoring the screw penetrations.

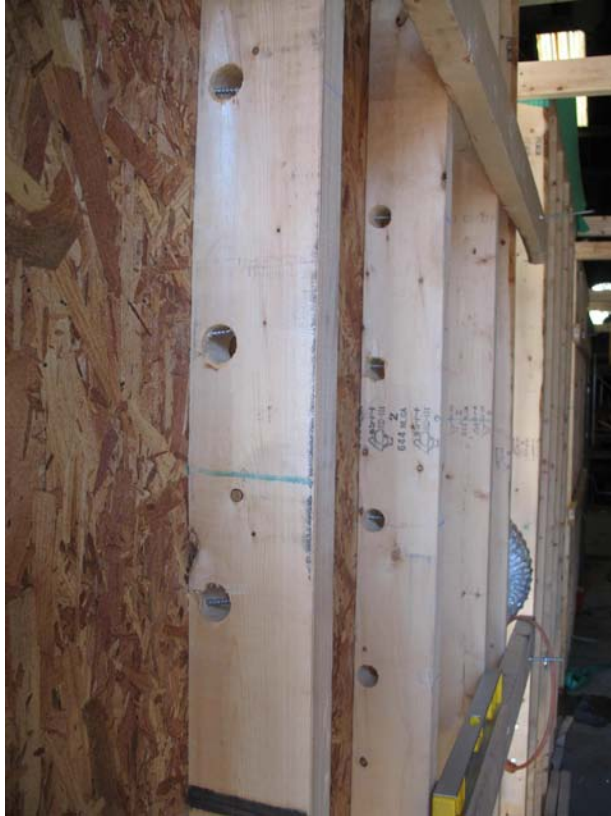
Figure 2; Observation holes at anchoring screws in wood studs

Test Samples: Type 1; Tru-Brix Siding installed over 7/16" OSB Sheathing on untreated 2x4 wood studs spaced at 16-inches on center. Three wall samples of 6-ft x 6-ft were built and two were tested. The E514 Test chamber was 40"W x 48"H and attached in the approximate center horizontally, and 2 courses from the top, on each test wall. (See Figure 1) Holes were drilled in the wood studs close to the sheathing in order to expose eight Siding attachment screws for observation. (See Figure 2)

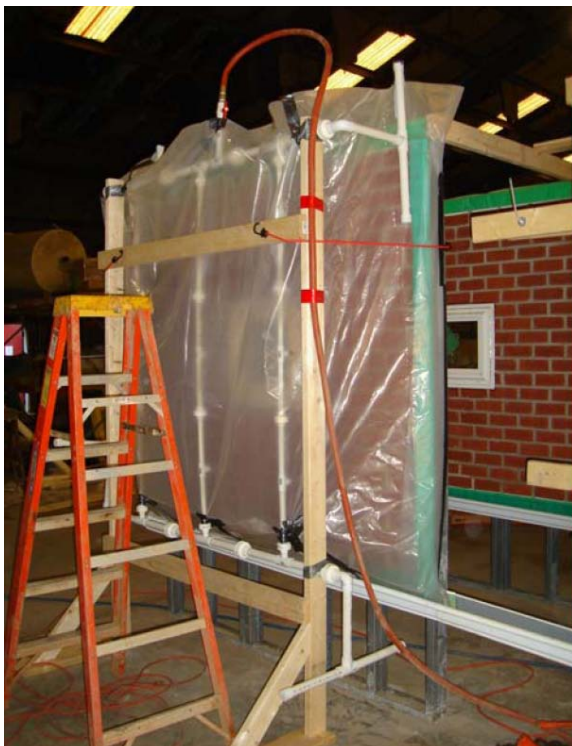
Figure 3; E1105 Setup

Test samples: Type 1; Tru-Brix Siding installed over 5/8” Fiberglass faced exterior gypsum sheathing (Georgia Pacific Dens-Glass Gold) on 18 gage steel studs spaced at 16 inches on center. A flanged 16” x 16” fixed window was installed with standard construction methods. The E1109 spray test apparatus was set up and plastic covering was installed around the test apparatus. See Figure 3.

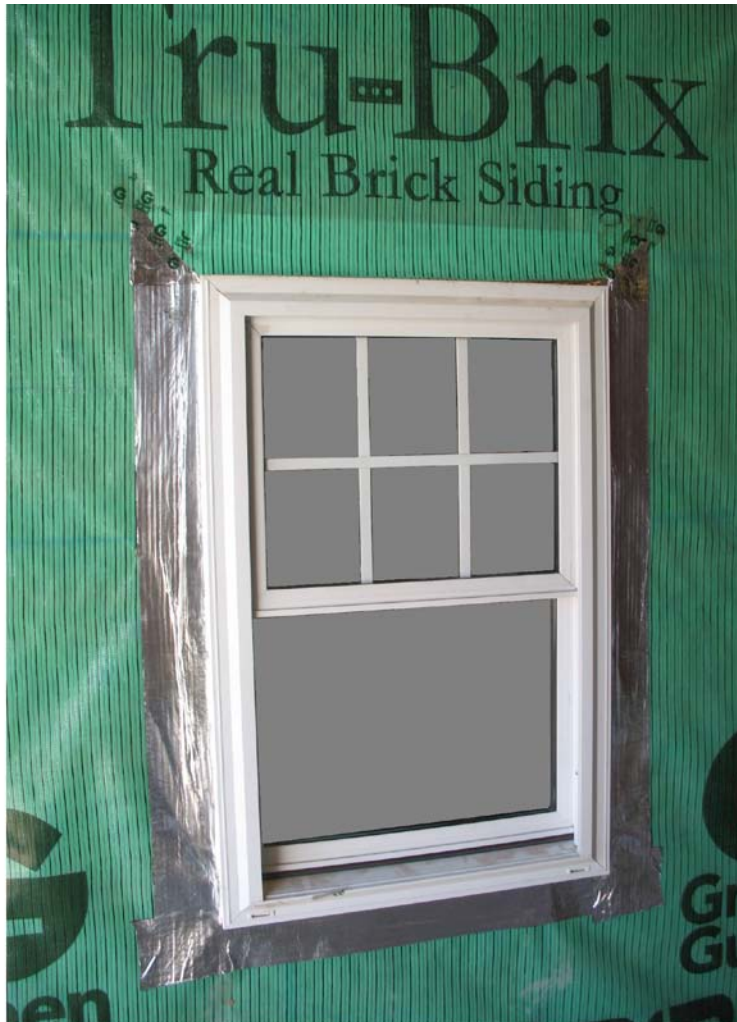
Figure 5; Window with Drainage Wrap and Flashing

Results; Examinations of the results show that correct window flashing details are required to prevent water penetration at window heads. The correct installation is shown in Figure 5. The Drainage Wrap must be cut to install window head flashing underneath the Wrap. Any moisture in the Drainage Wrap will then be removed from the wall by the window head flashing.
